**CONSERVING A
GOTHIC REVIVAL CHURCH
IN WASHINGTON, D.C.**

Capitol Hill Icon Restored

The 1888 Gothic Revival St. Mark's Episcopal Church gets a much needed overhaul.

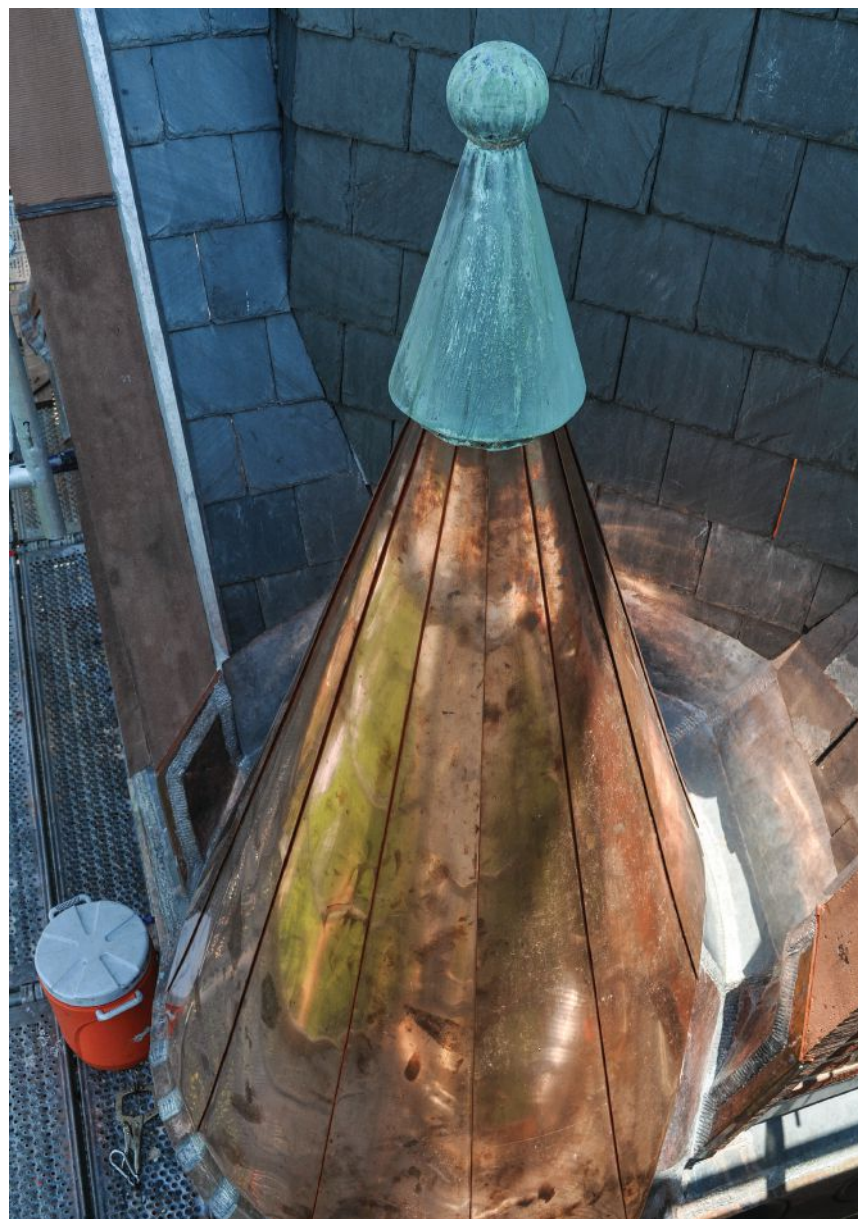
LEFT The four turrets on the north elevation tower of St. Mark's Episcopal Church in Washington, D.C. were repaired and restored by Aeon Preservation.

BELOW The new copper roofs of the turrets have an updated seam pattern that's stronger and more water-resistant than the original but just as aesthetically accurate.

The copper roofs and the underlying wood of the four turrets and spire on the tower were so damaged that they also had to be replaced.

“The new roofs have an updated seam pattern custom designed to be stronger and more water-resistant without changing the aesthetic of the turrets,” Narvaez says. “And we installed new flashing with an updated design to make them more watertight.”

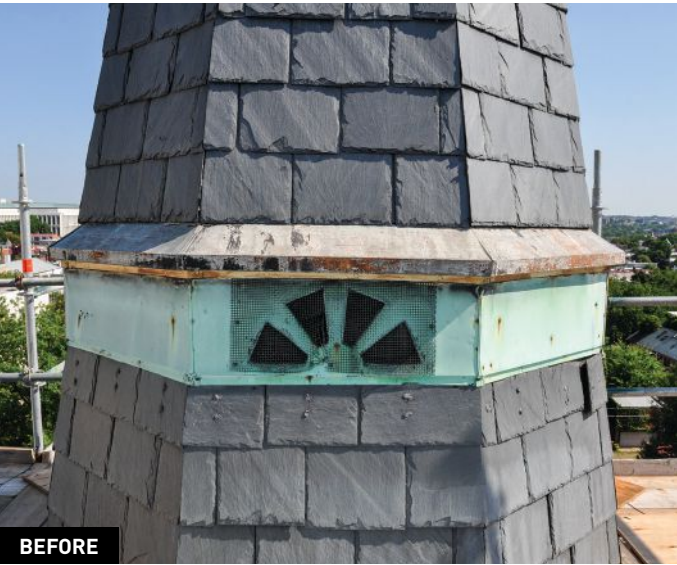
ABOVE The main tower of Mark’s Episcopal Church in Washington, D.C., had four turrets that were extensively repaired and restored by the Aeon Preservation team. This entailed rebuilding wooden framing, new copper roofing and cladding, fabrication of new decorative stones, and rebuilding large sections of masonry.

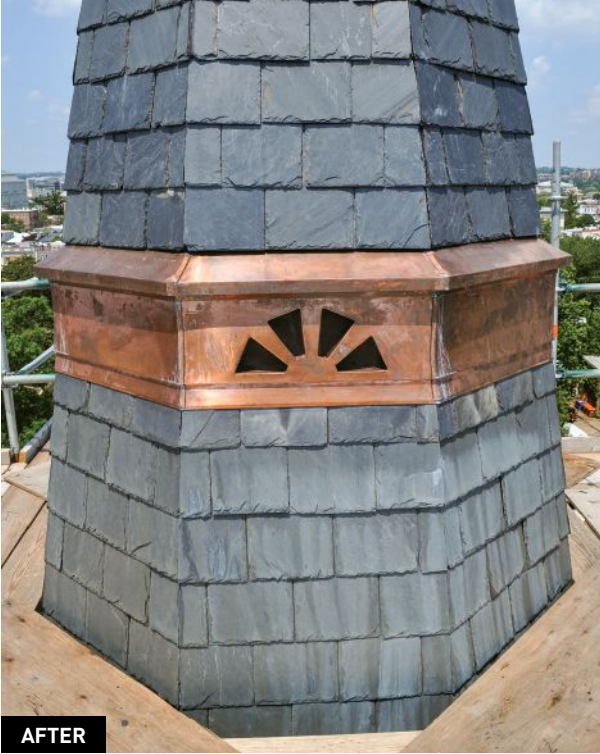
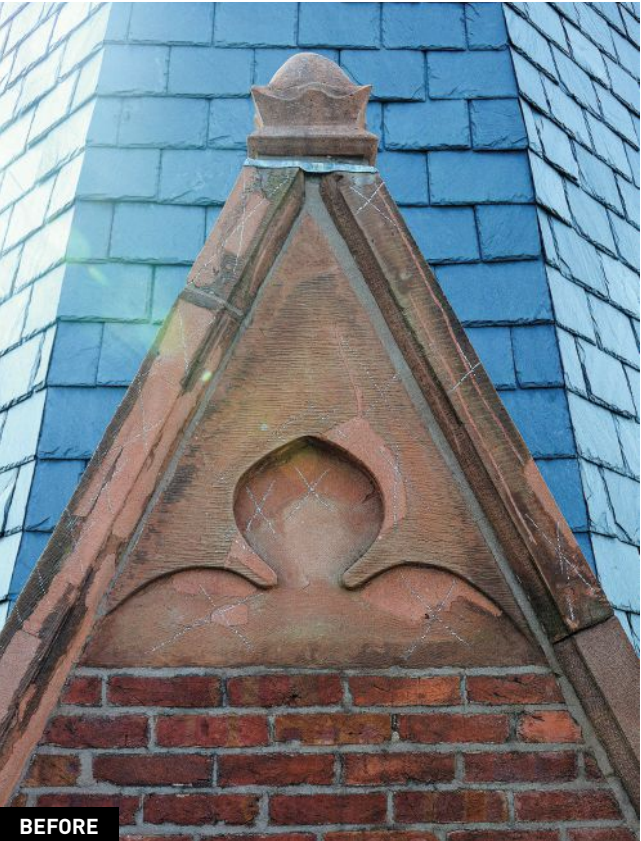
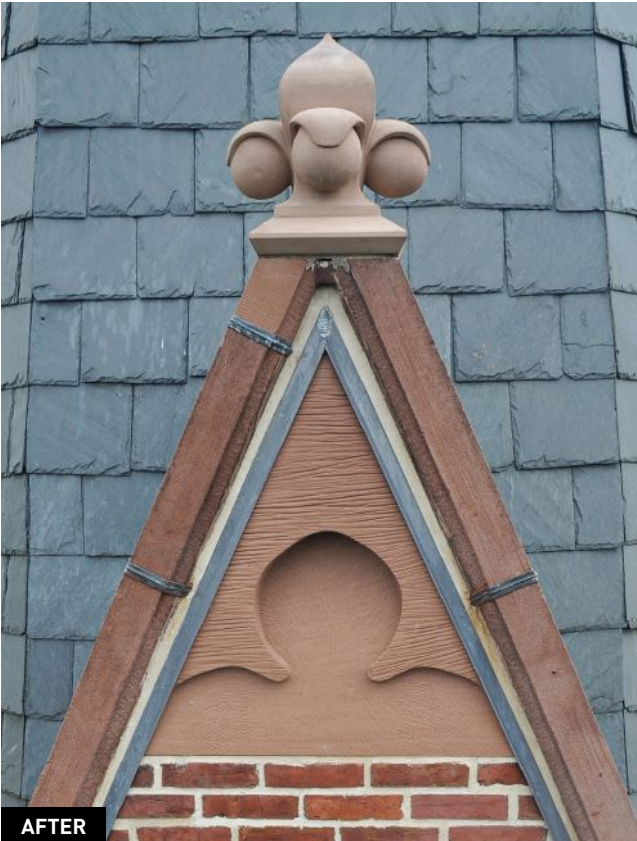
ABOVE One of the more challenging aspects of this project was trying to recreate the heavily damaged finials on the main tower. They had been patched and re-carved so many times that they no longer resembled anything like the original highly ornamental finials. The restoration team only had one historic low-resolution image to help guide the replacement.

During the restoration, the team discovered, while searching period photos, that the tower turrets’ inverted-pineapple-shaped finials post-dated the

building. The originals—hand-carved, three-dimensional fleurs-de-lis—were replicated.
